Environmental Site Assessment

Proposed Embrey Dam Sediment Disposal Site

Submitted: February 28, 2002

IMS Environmental Services
929 Professional Place
Chesapeake, Virginia
757.436.3000

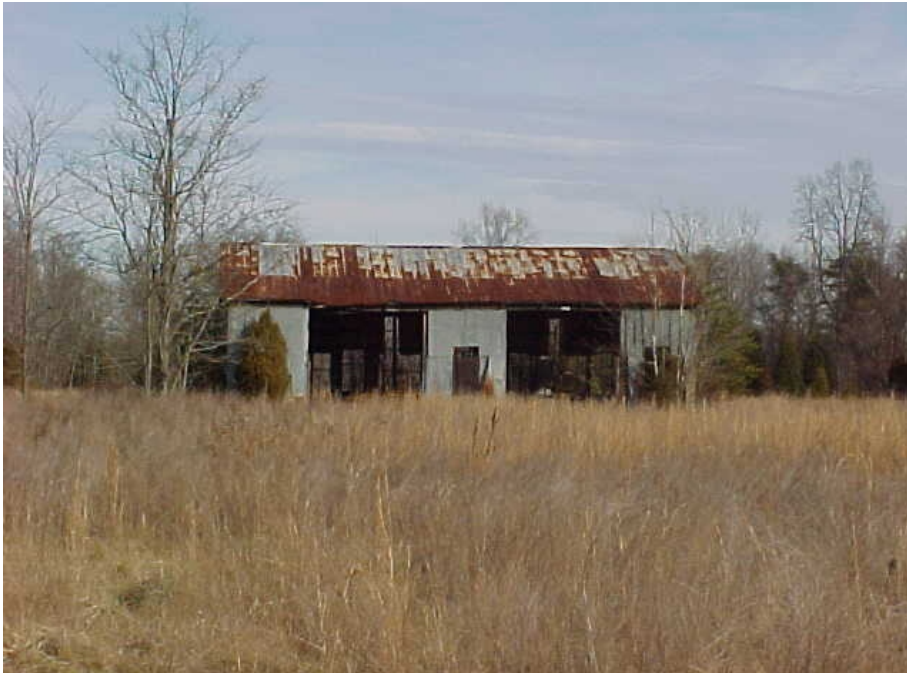
Top Left: View of old building located on the subject property.

The frame of an old sheet metal building is located next to the site access road to the southeast of the concrete rack structure. The former building dimensions are thirty-six (36) feet by sixty (60) feet. Scattered debris is located inside the frame of the old building. The southern side of the sheet metal building was designated as the location for test pit TP-9, and test pit TP-10 was excavated inside the building as displayed in Figure 2. A slight petroleum odor was noted in test pit TP-10. Therefore, a soil sample was collected from this test pit location. Further discussion of the soil sample collected from test pit TP-10 is included in Section 4.1.1. The soil composition and description of these test pits are included in Appendix A.

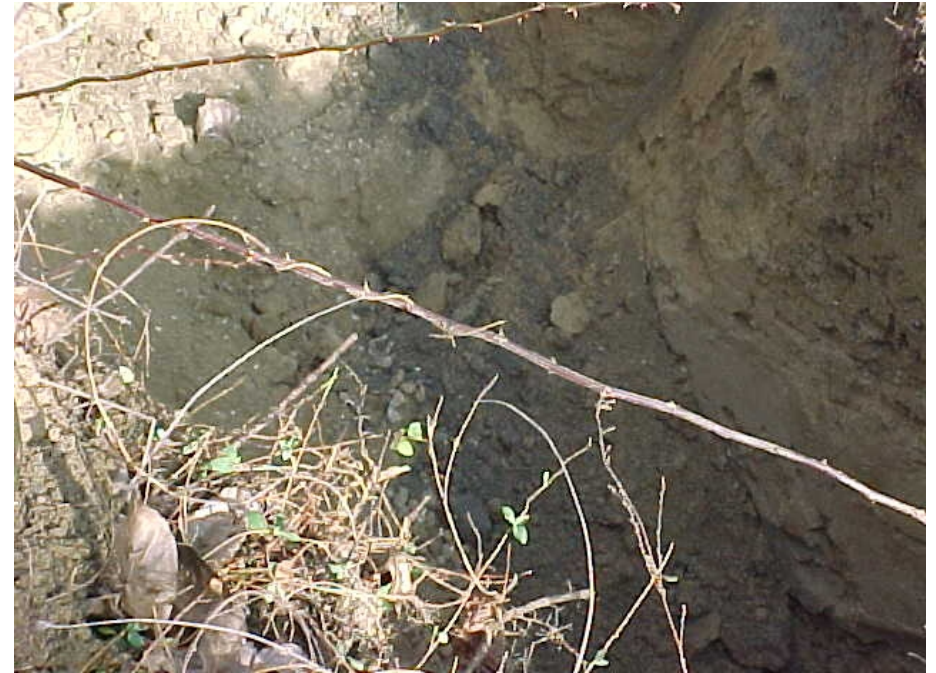
Top Right: View of excavated test pit (TP-1).

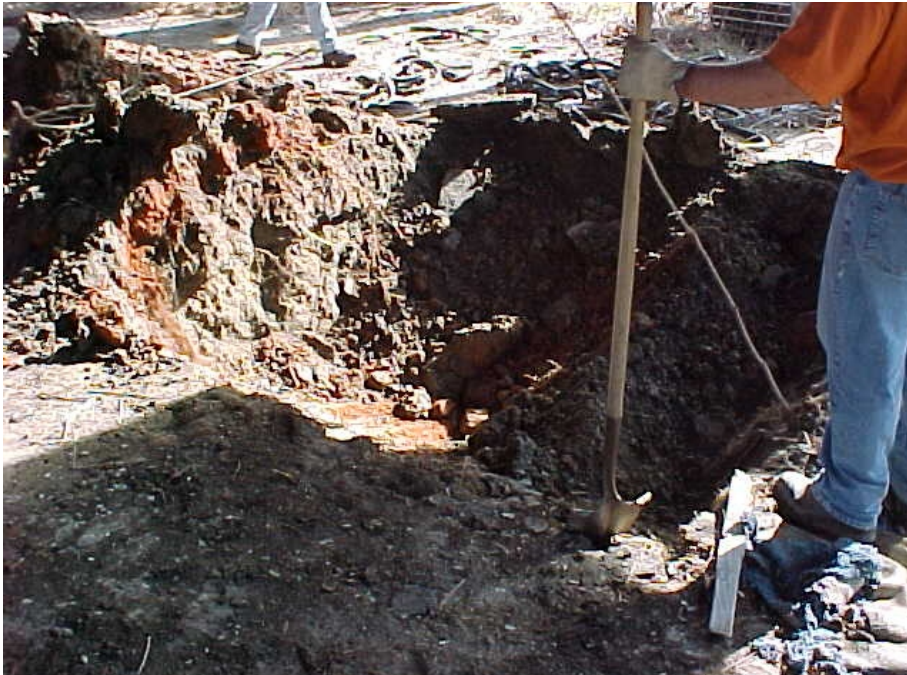
Top Left: View of excavated test pit (TP-10).

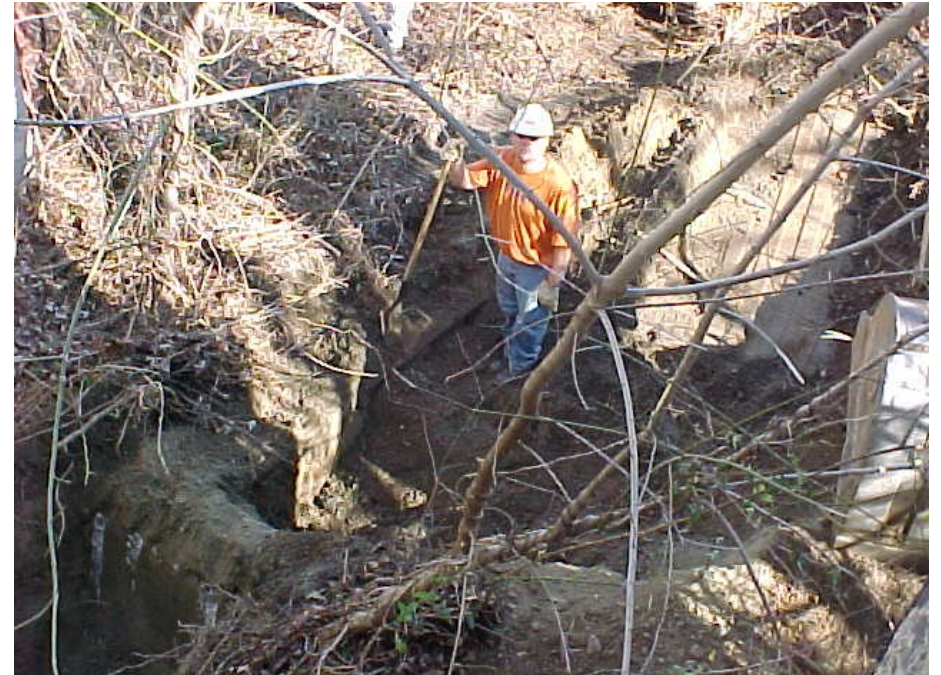
Top Right: View of excavated test pit (TP-11).

appears to be where the rock was crushed and loaded onto the trucks for distribution, when the facility was operating. Test pit TP-11 was excavated in front of the large concrete structure. Test pits TP-12 and TP-13 were excavated on top of the manmade hillside, as shown in Figure 2. No adverse environmental conditions were identified in the soil of any of the test pits TP-11 through TP-13. The soil composition and description of these test pits are included in Appendix A.

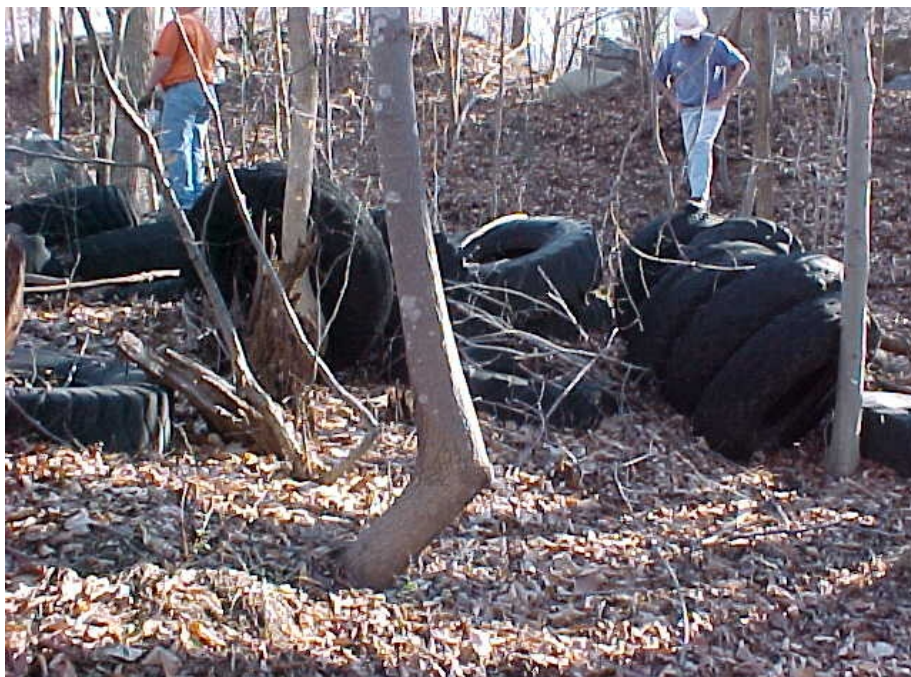
Top Left: View of tire pile located on the subject property.

IMS has determined that there will be considerable costs associated with the site clean up and removal of debris at the subject property. There is a tire pile, consisting of approximately 31 large tractor tires located on the northwestern corner of the property. The volume of the debris is approximately two hundred and eighty-eight (288) cubic yards. On the eastern portion of the property, on the other side of the dirt access road there is a large pile of metal drums. The volume of the debris is approximately four hundred and forty-four (444) cubic yards.

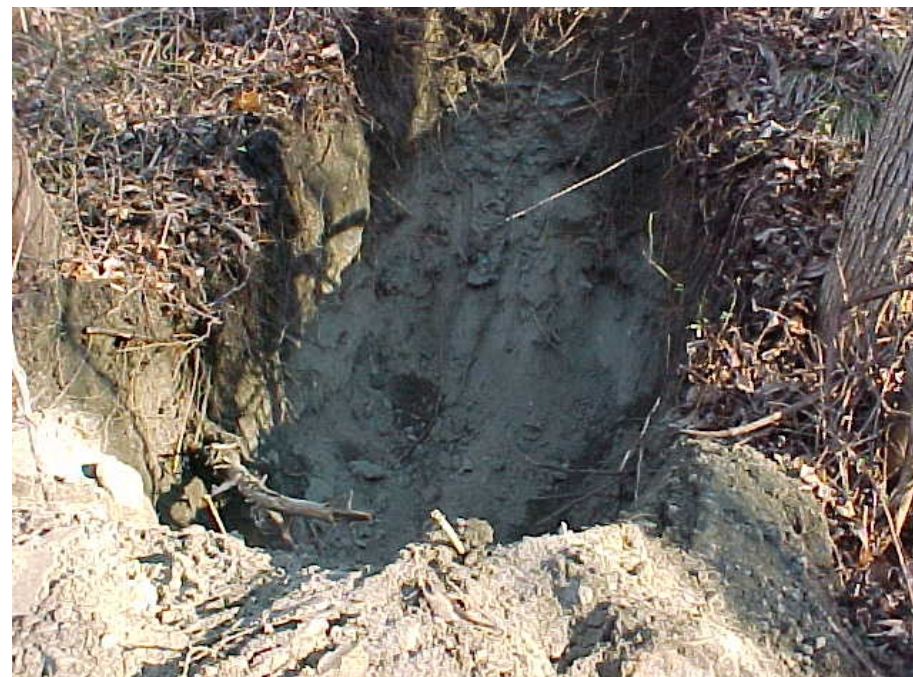
Top Right: View of excavated test pit (TP-16), located under the tire pile.

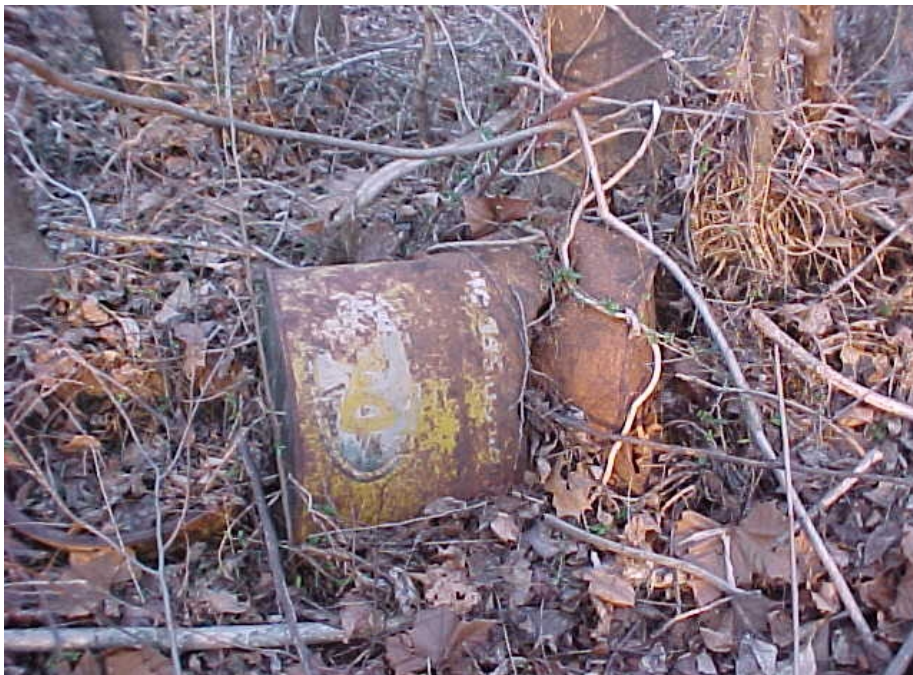
Top Left: View of 55 gallon drum containing unknown material located on the subject property.

During excavation activities around a debris pile on the eastern portion of the subject property (Figure 2), two non-labeled 55-gallon drums possibly containing hazardous materials were discovered. The two 55-gallon drums appeared to possibly have some contents still in them. One of these drums was marked as containing diesel, but the other drum was clearly not marked or labeled. At this time, excavation activities ceased in order to properly prepare a team of personnel to investigate the 55-gallon drums, and any other drums that may still exist intact in the subsurface of the debris pile located on the eastern portion of the subject property.

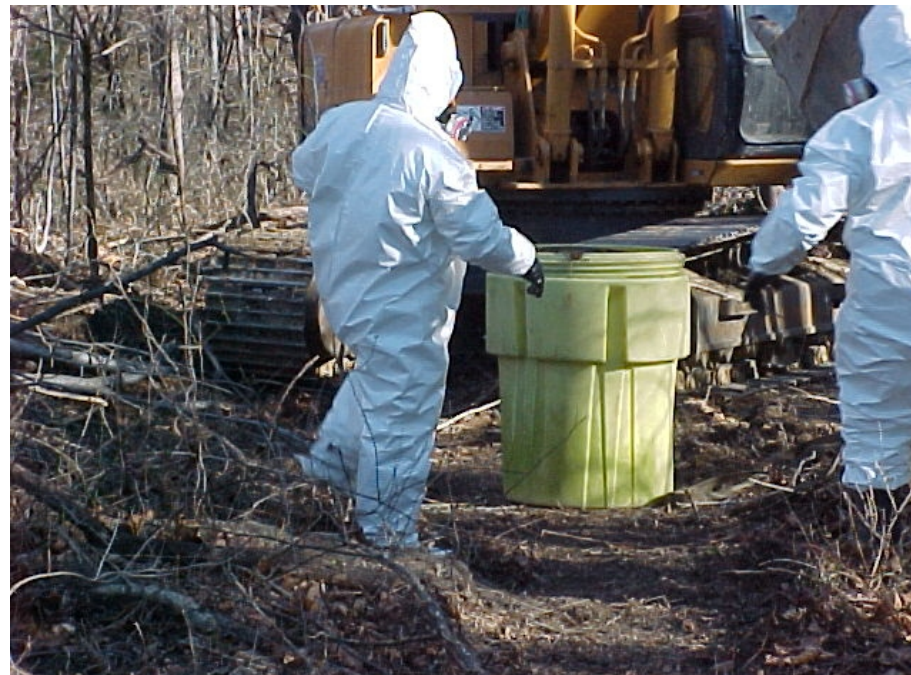
Top Right: View of 55 gallon drum being overpacked for removal off site.

IMS secured the 55-gallon drum marked diesel in a 90-gallon polyurethane overpack to stabilize and prepare the drum for sampling. The other unmarked 55-gallon drum was discovered to be empty. The majority of the remaining drums on the surface of the debris pile were already rusted through, and completely empty. IMS also dug test pits in search for any drums, which may be buried in the subsurface. No additional drums full of liquid were encountered during test pit excavation on this date.
